# Manhole Inspection Summary

Manhole # S03CC2016MH

Insp Date: **7/24/06 8:23 AM**

**Location** Address: **2900 W STRATHMORE AVE** Cross Street: **BAYWOOD AVE**

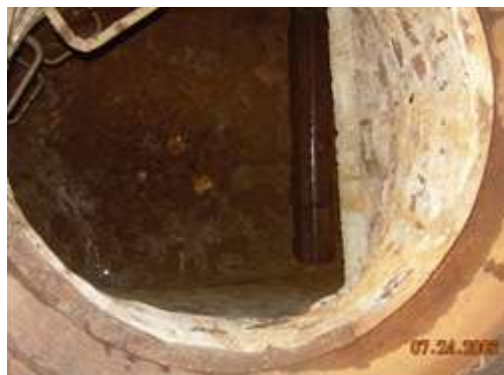
Top View

Infiltration: ☐ None ☒ **Joint** ☐ Cracks ☐ Mortar ☐ Roots ☐ Wall

Bench debris. Adjustment infiltration.

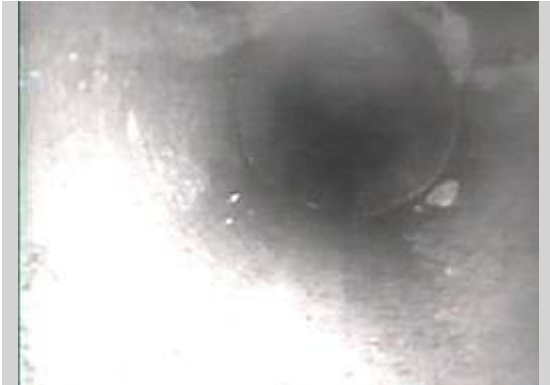
### 8 in. Circular Gravity Sewer Pipe Out @ 12 O'Clock

Pipe Material: **Clay** ☐ Pipe Lined

Invert Depth: **8.77** (ft.) Flow Characteristics: **Slow**

Deposits: ☒ None ☐ Mud ☐ Sludge ☐ Debris ☐ Grease

Infiltration: **None** Pipe Seal Cond: **Unknown**

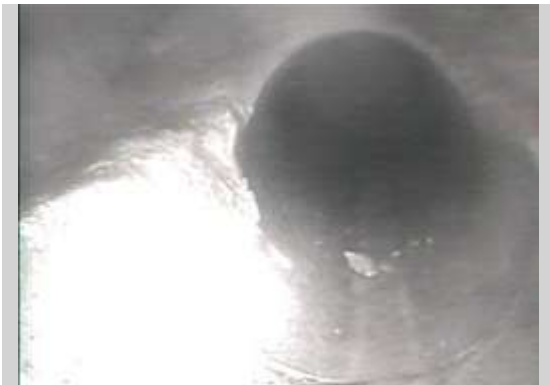
### 6 in. Circular Gravity Sewer Pipe In @ 6 O'Clock

Pipe Material: **Clay** ☐ Pipe Lined

Invert Depth: **8.50** (ft.) Flow Characteristics: **Slow**

Deposits: ☒ None ☐ Mud ☐ Sludge ☐ Debris ☐ Grease

Infiltration: **None** Pipe Seal Cond: **Unknown**
